Fout voegwerk

uit de praktijk...

Gertjan Timmer
monumentenadviseur

5 maart 2015

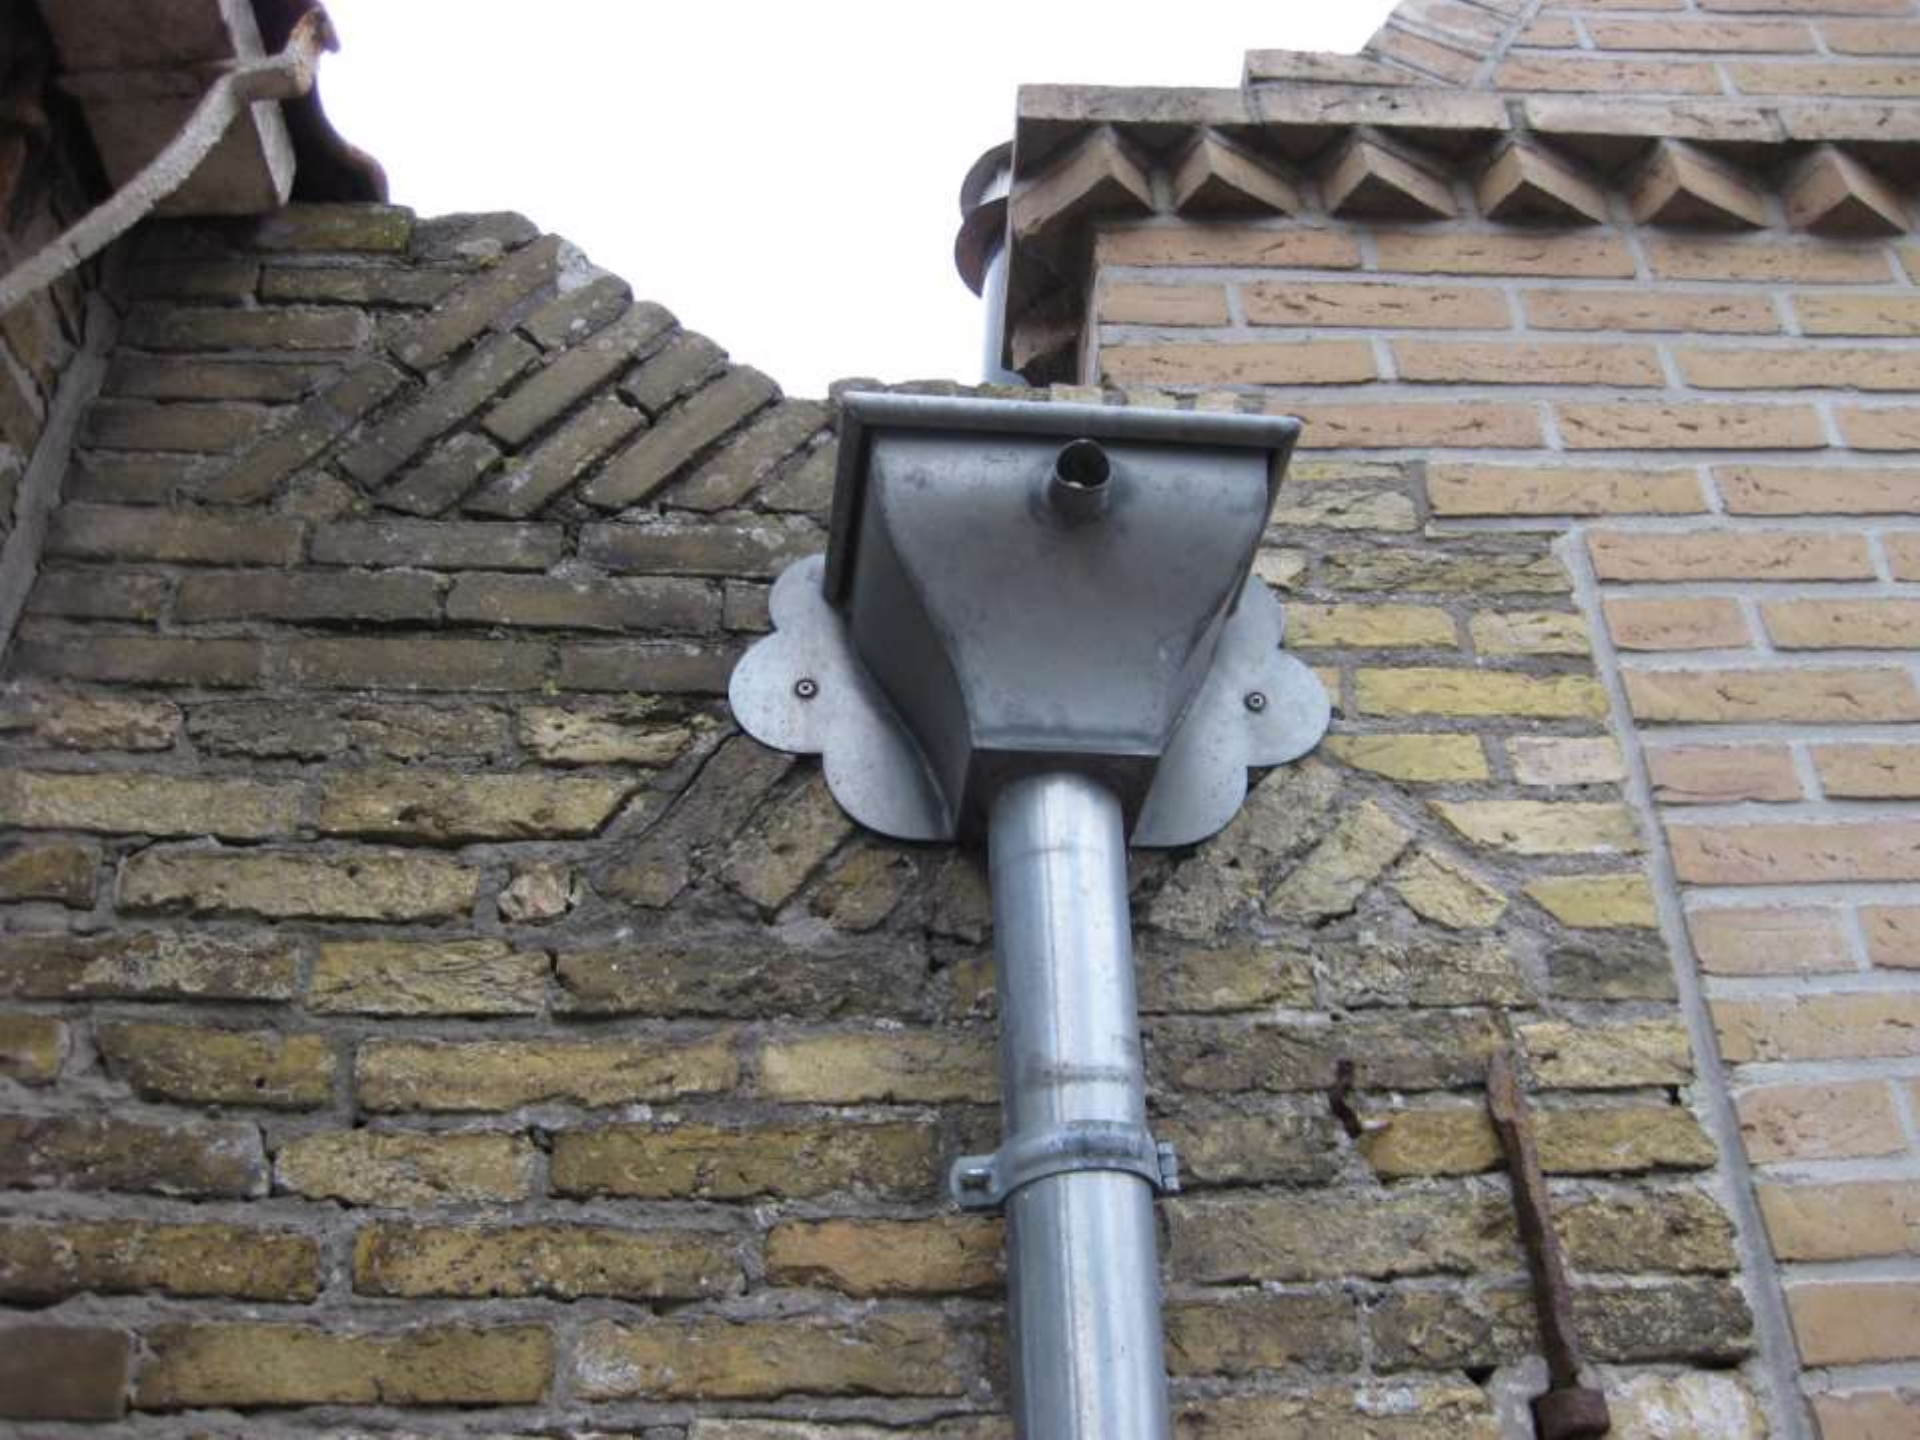
Voegwerk te hard en onvoldoende gesloten;
dit leidt tot vorstschade aan de stenen

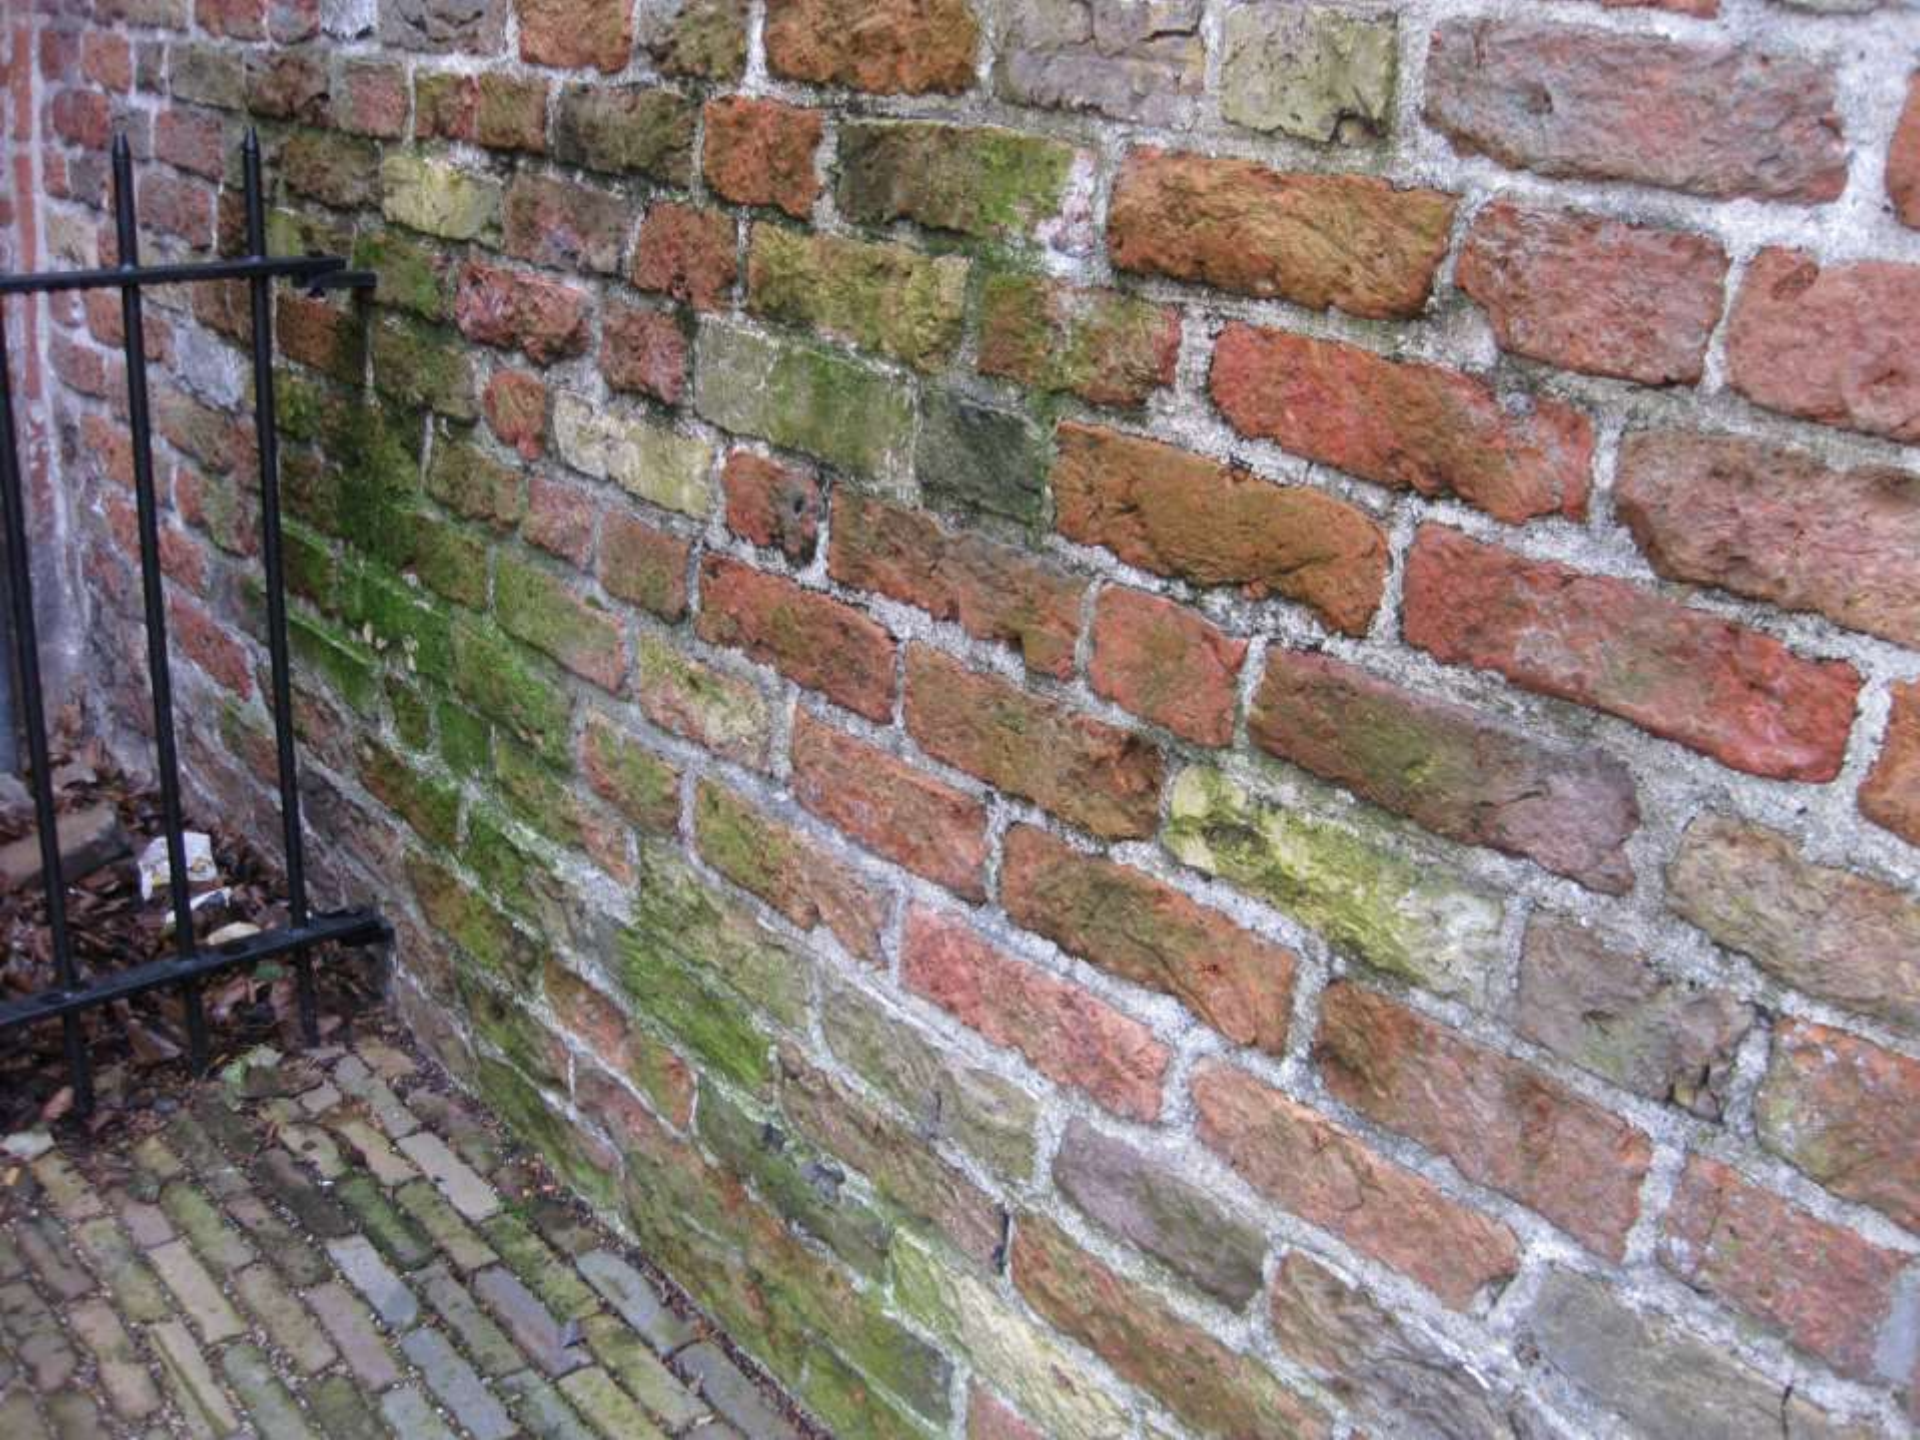
Voegen te hard en niet diep genoeg;
waardoor voegen loslaten

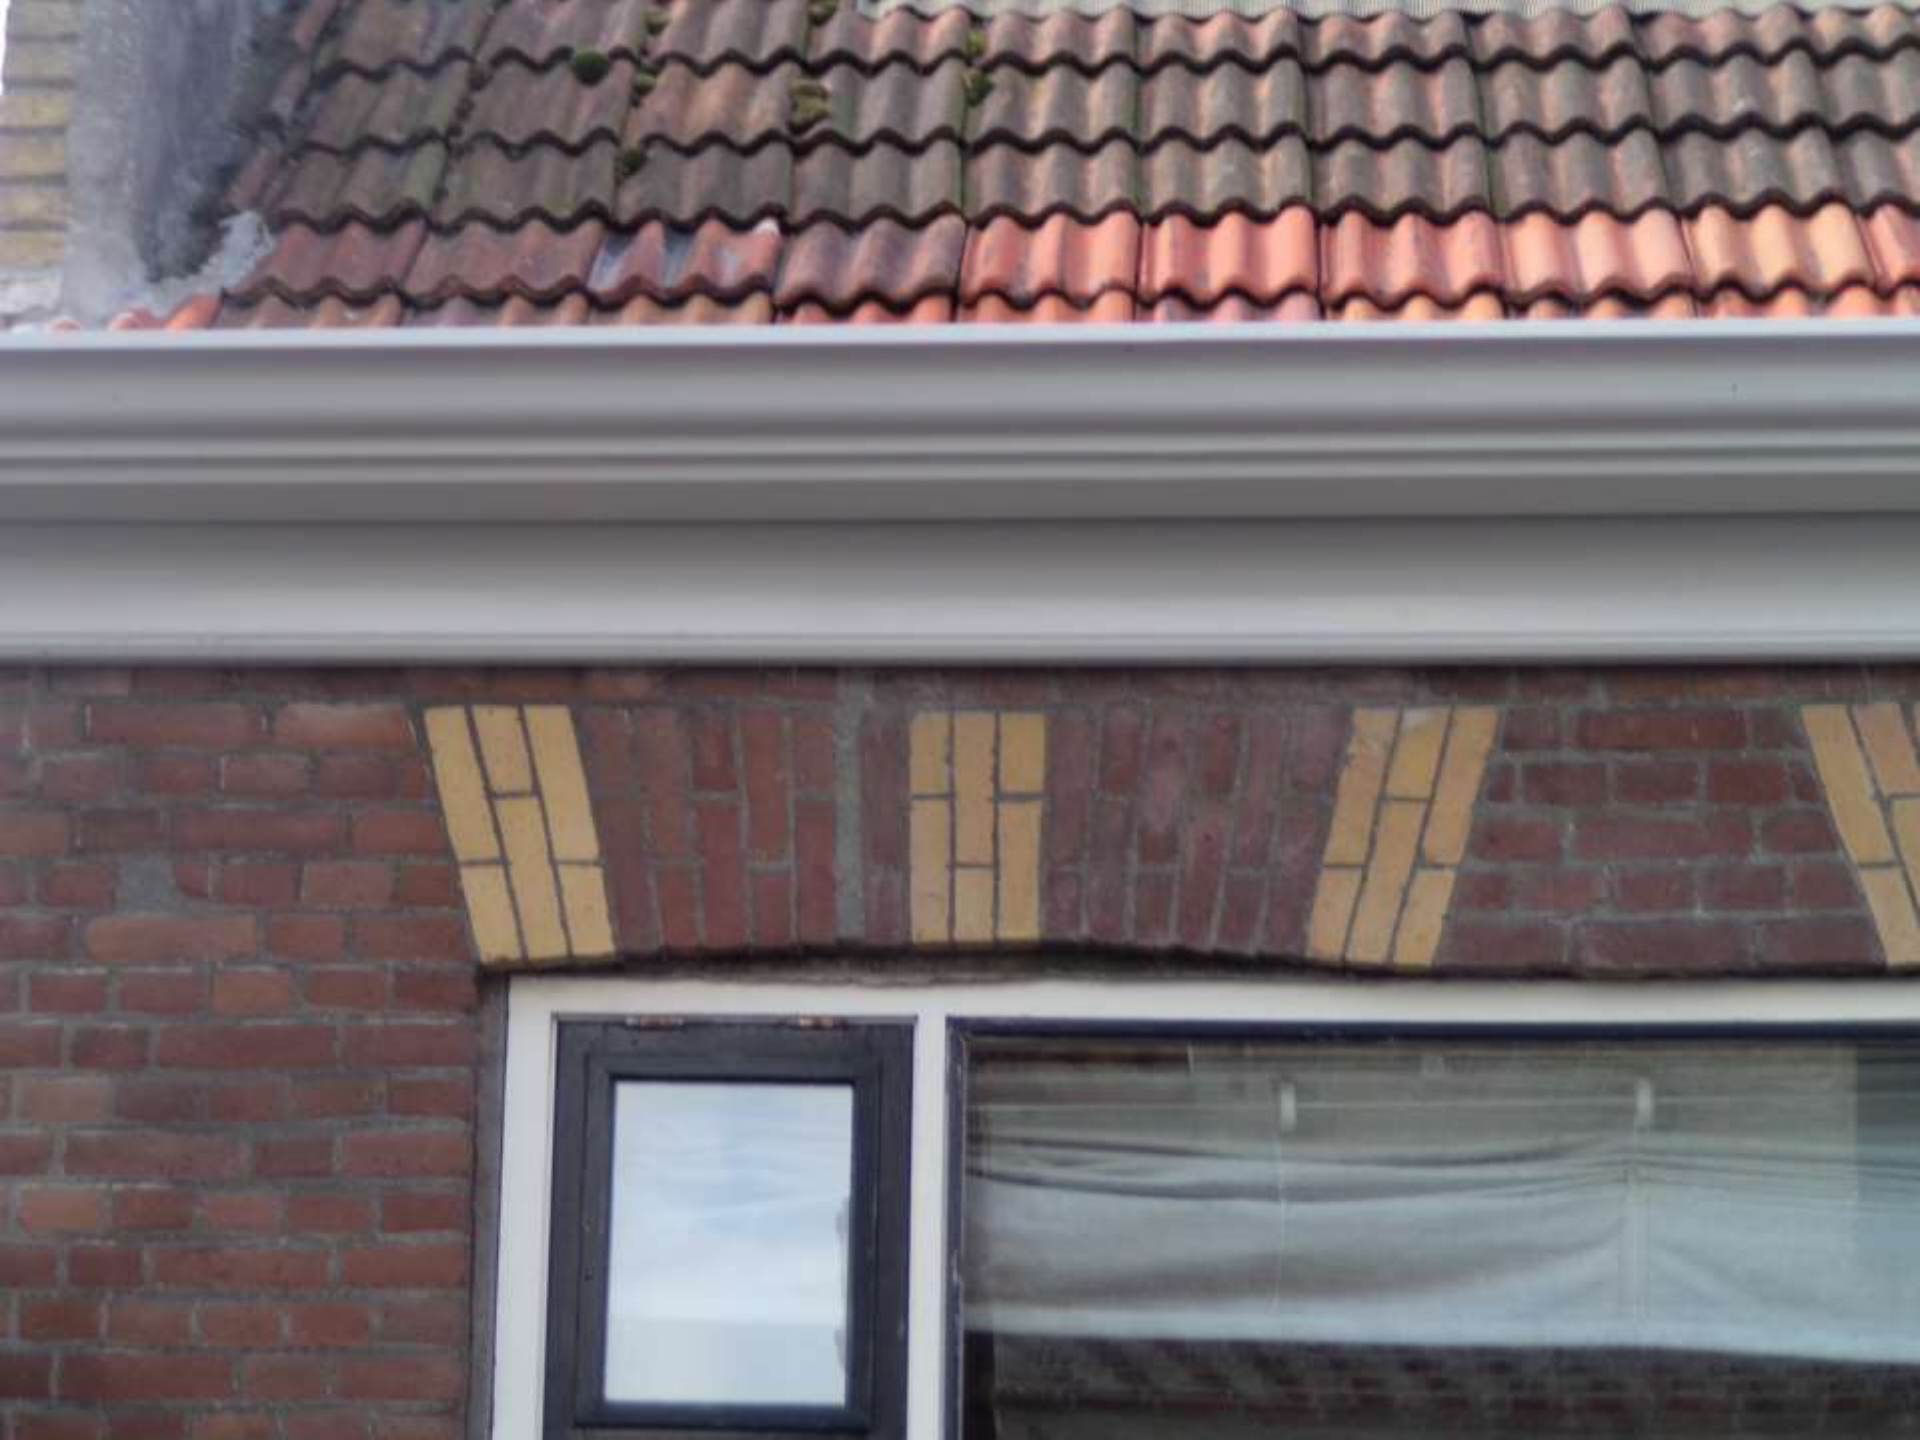
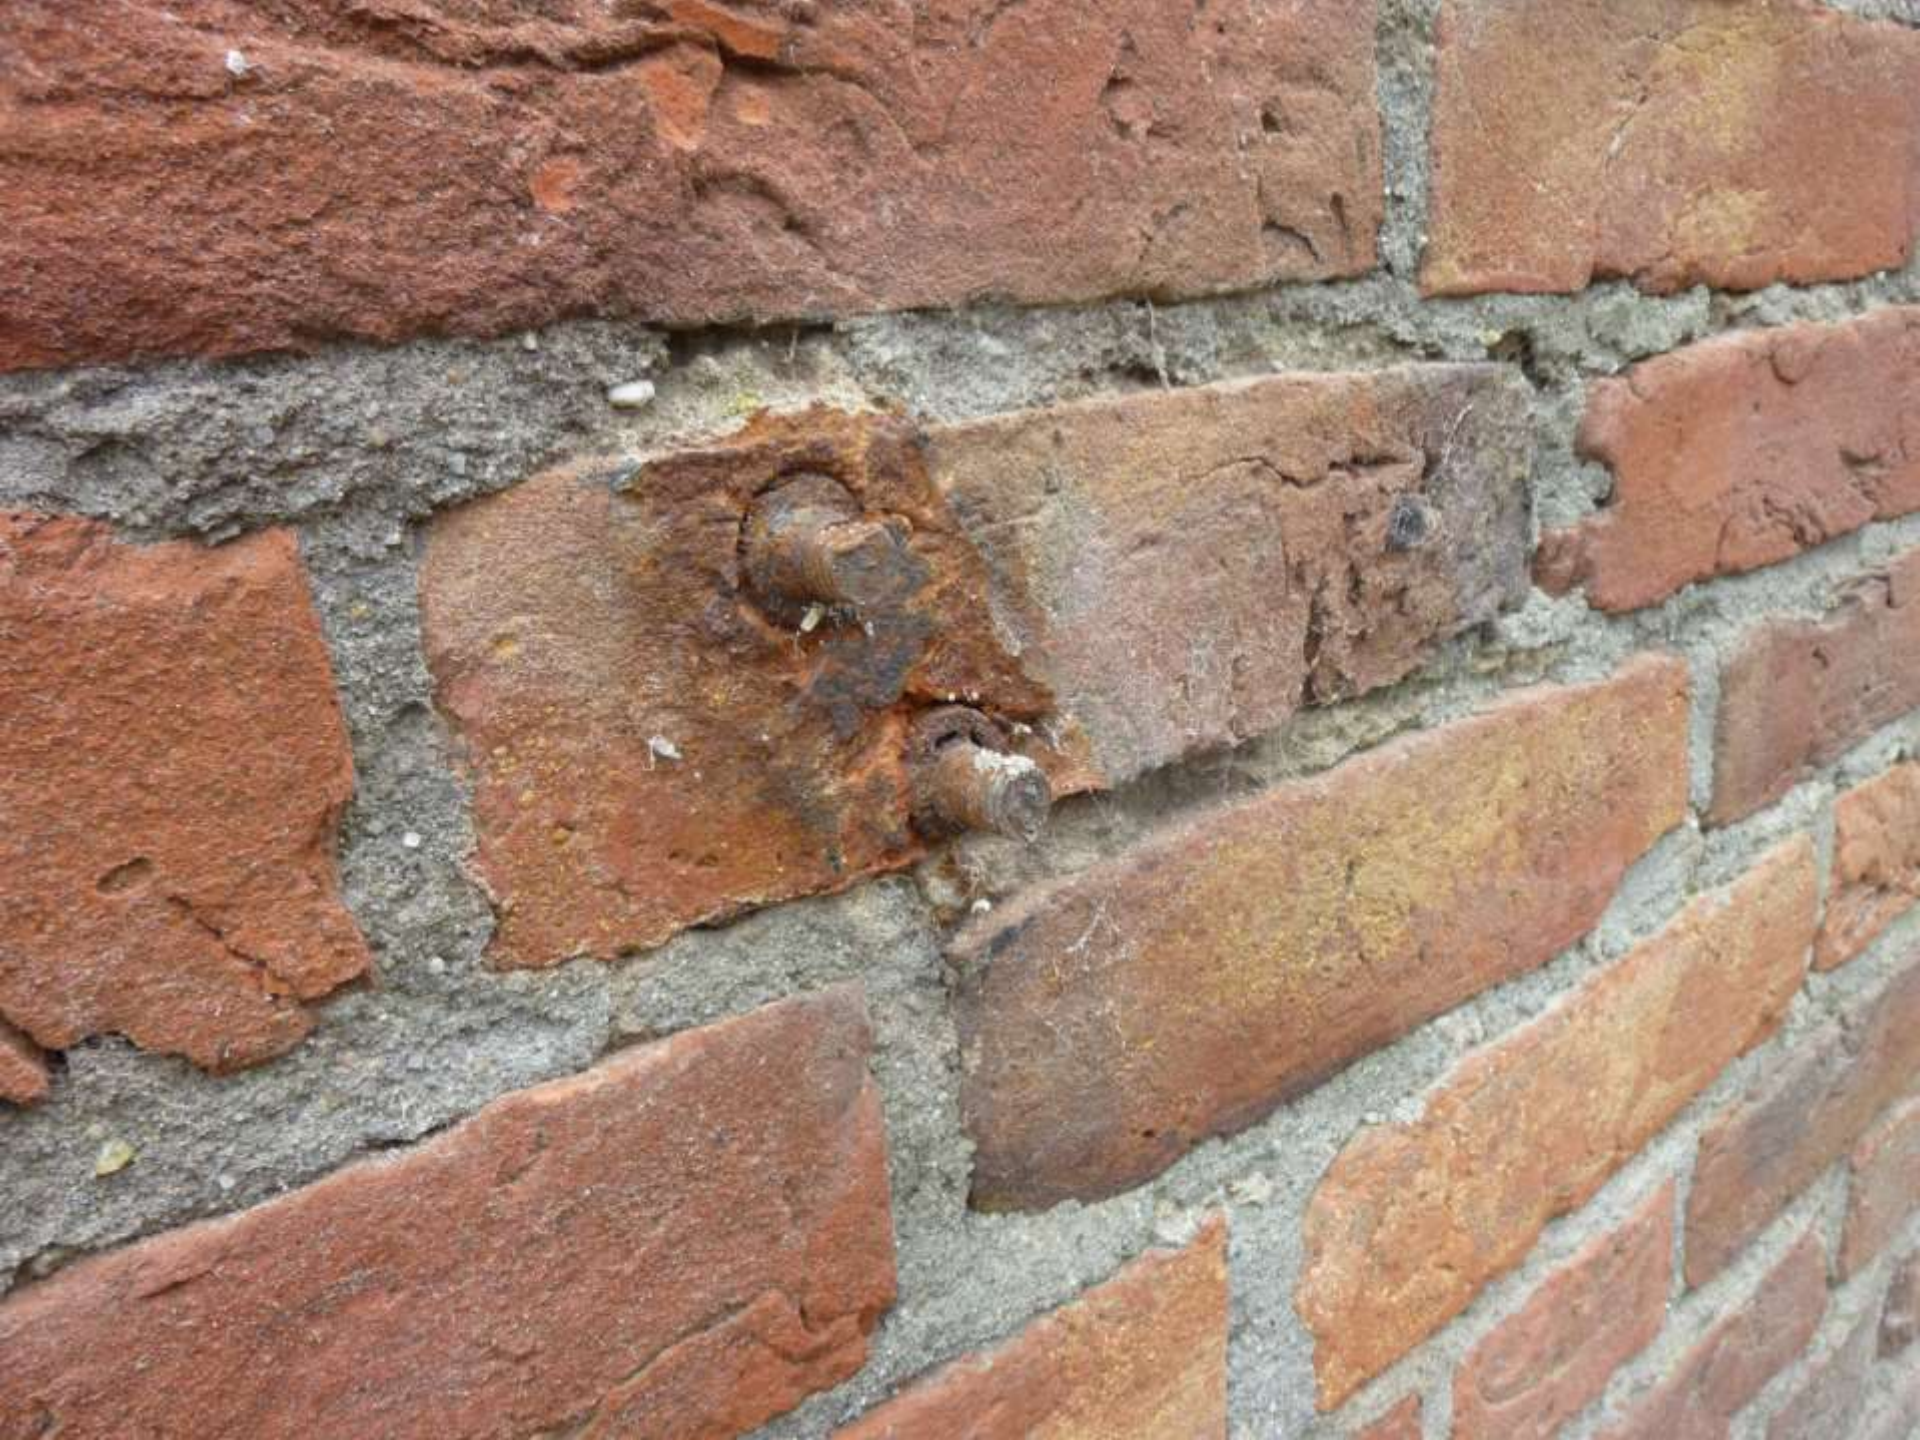
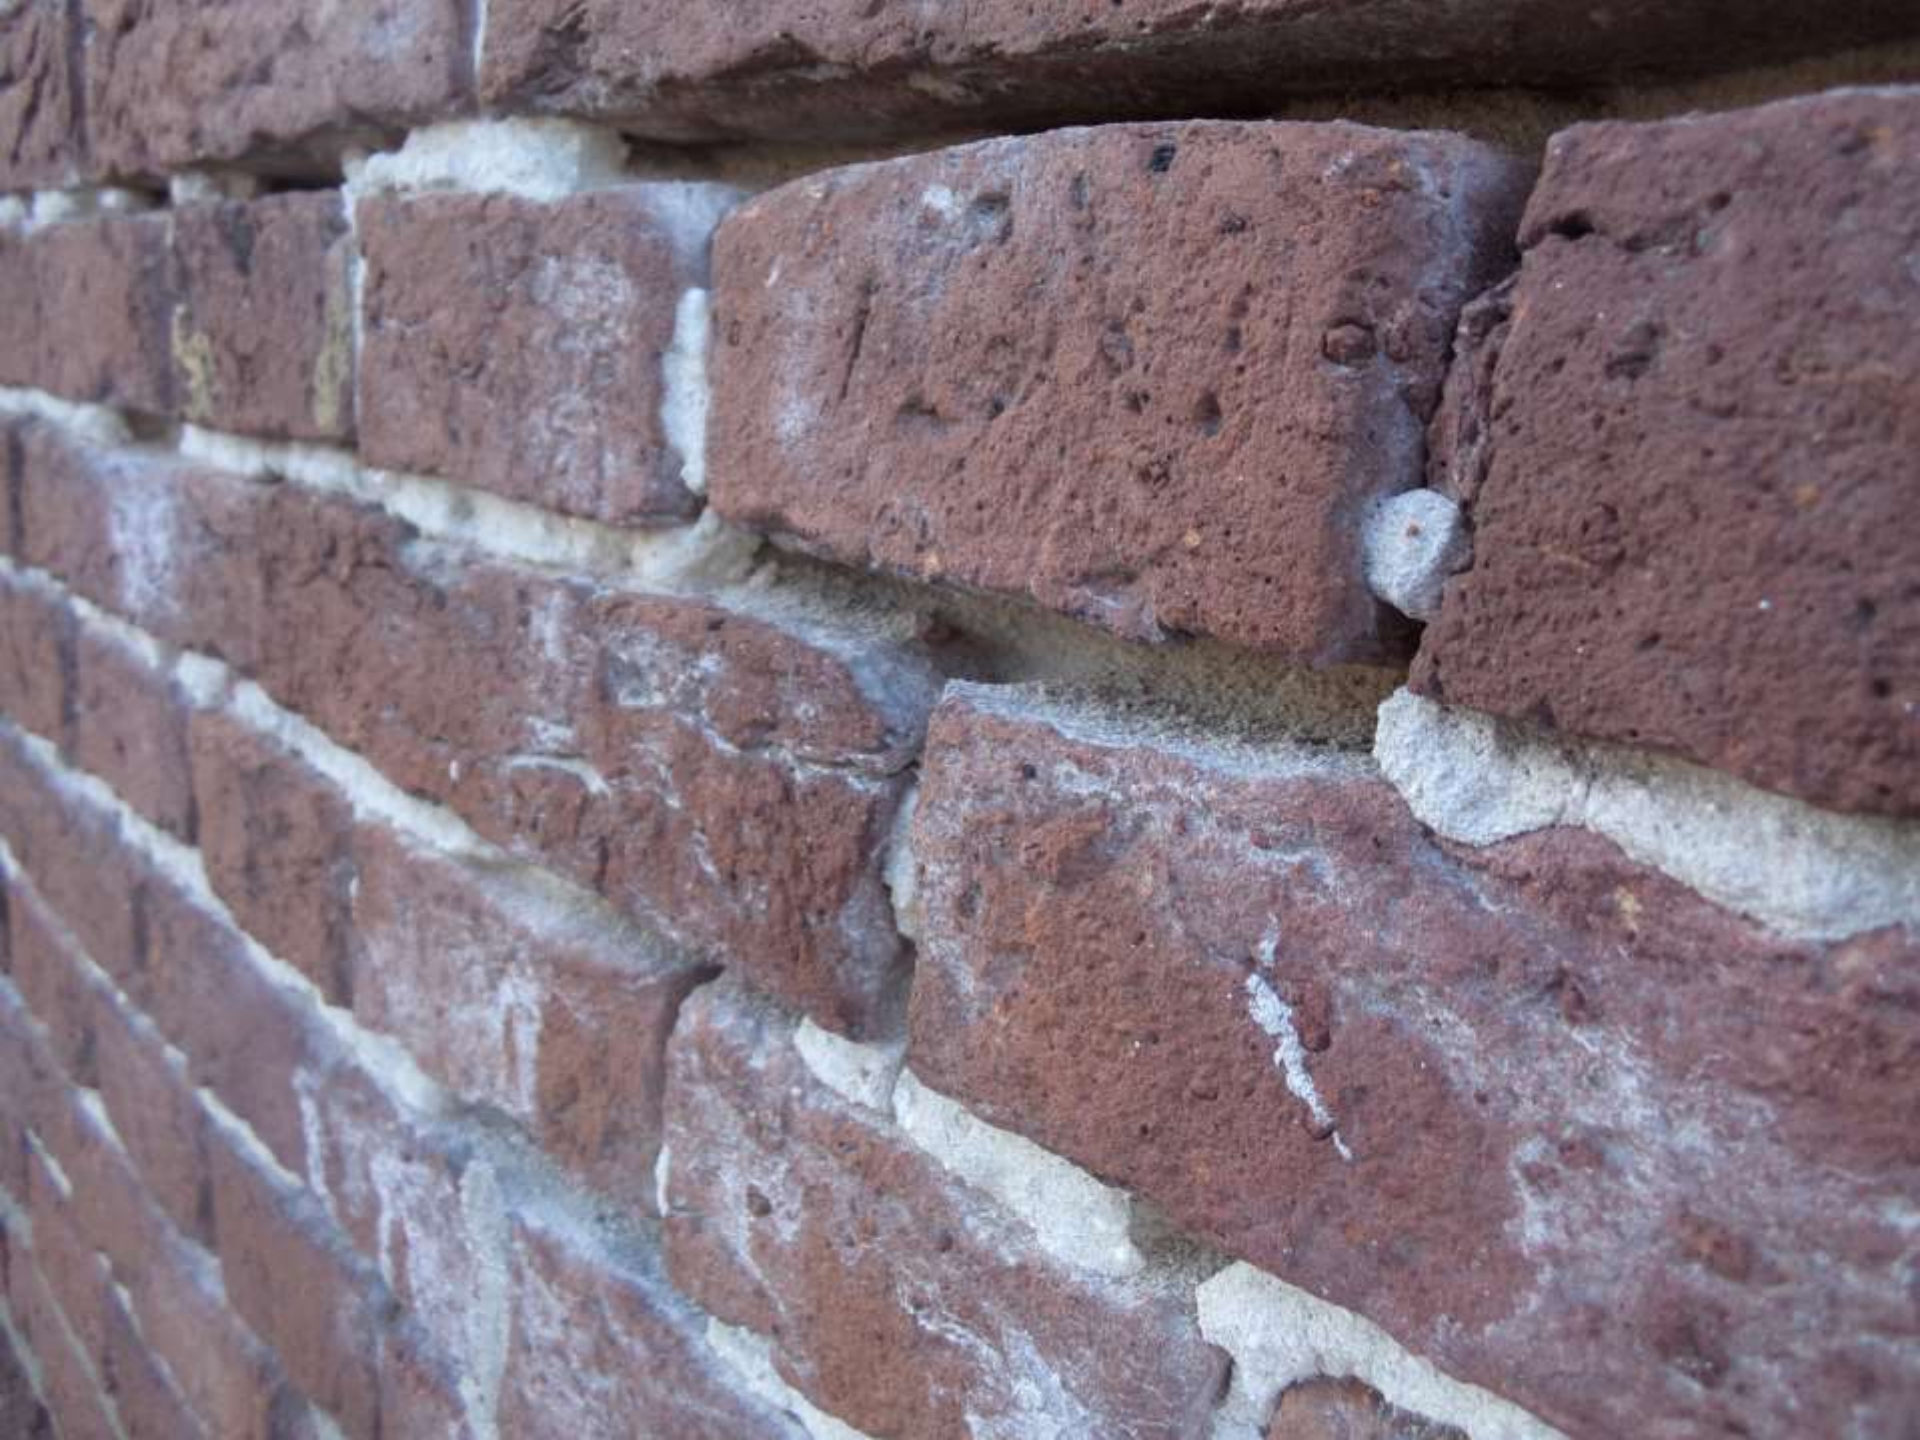
Hydrofoberen van oude gevels blijft riskant!

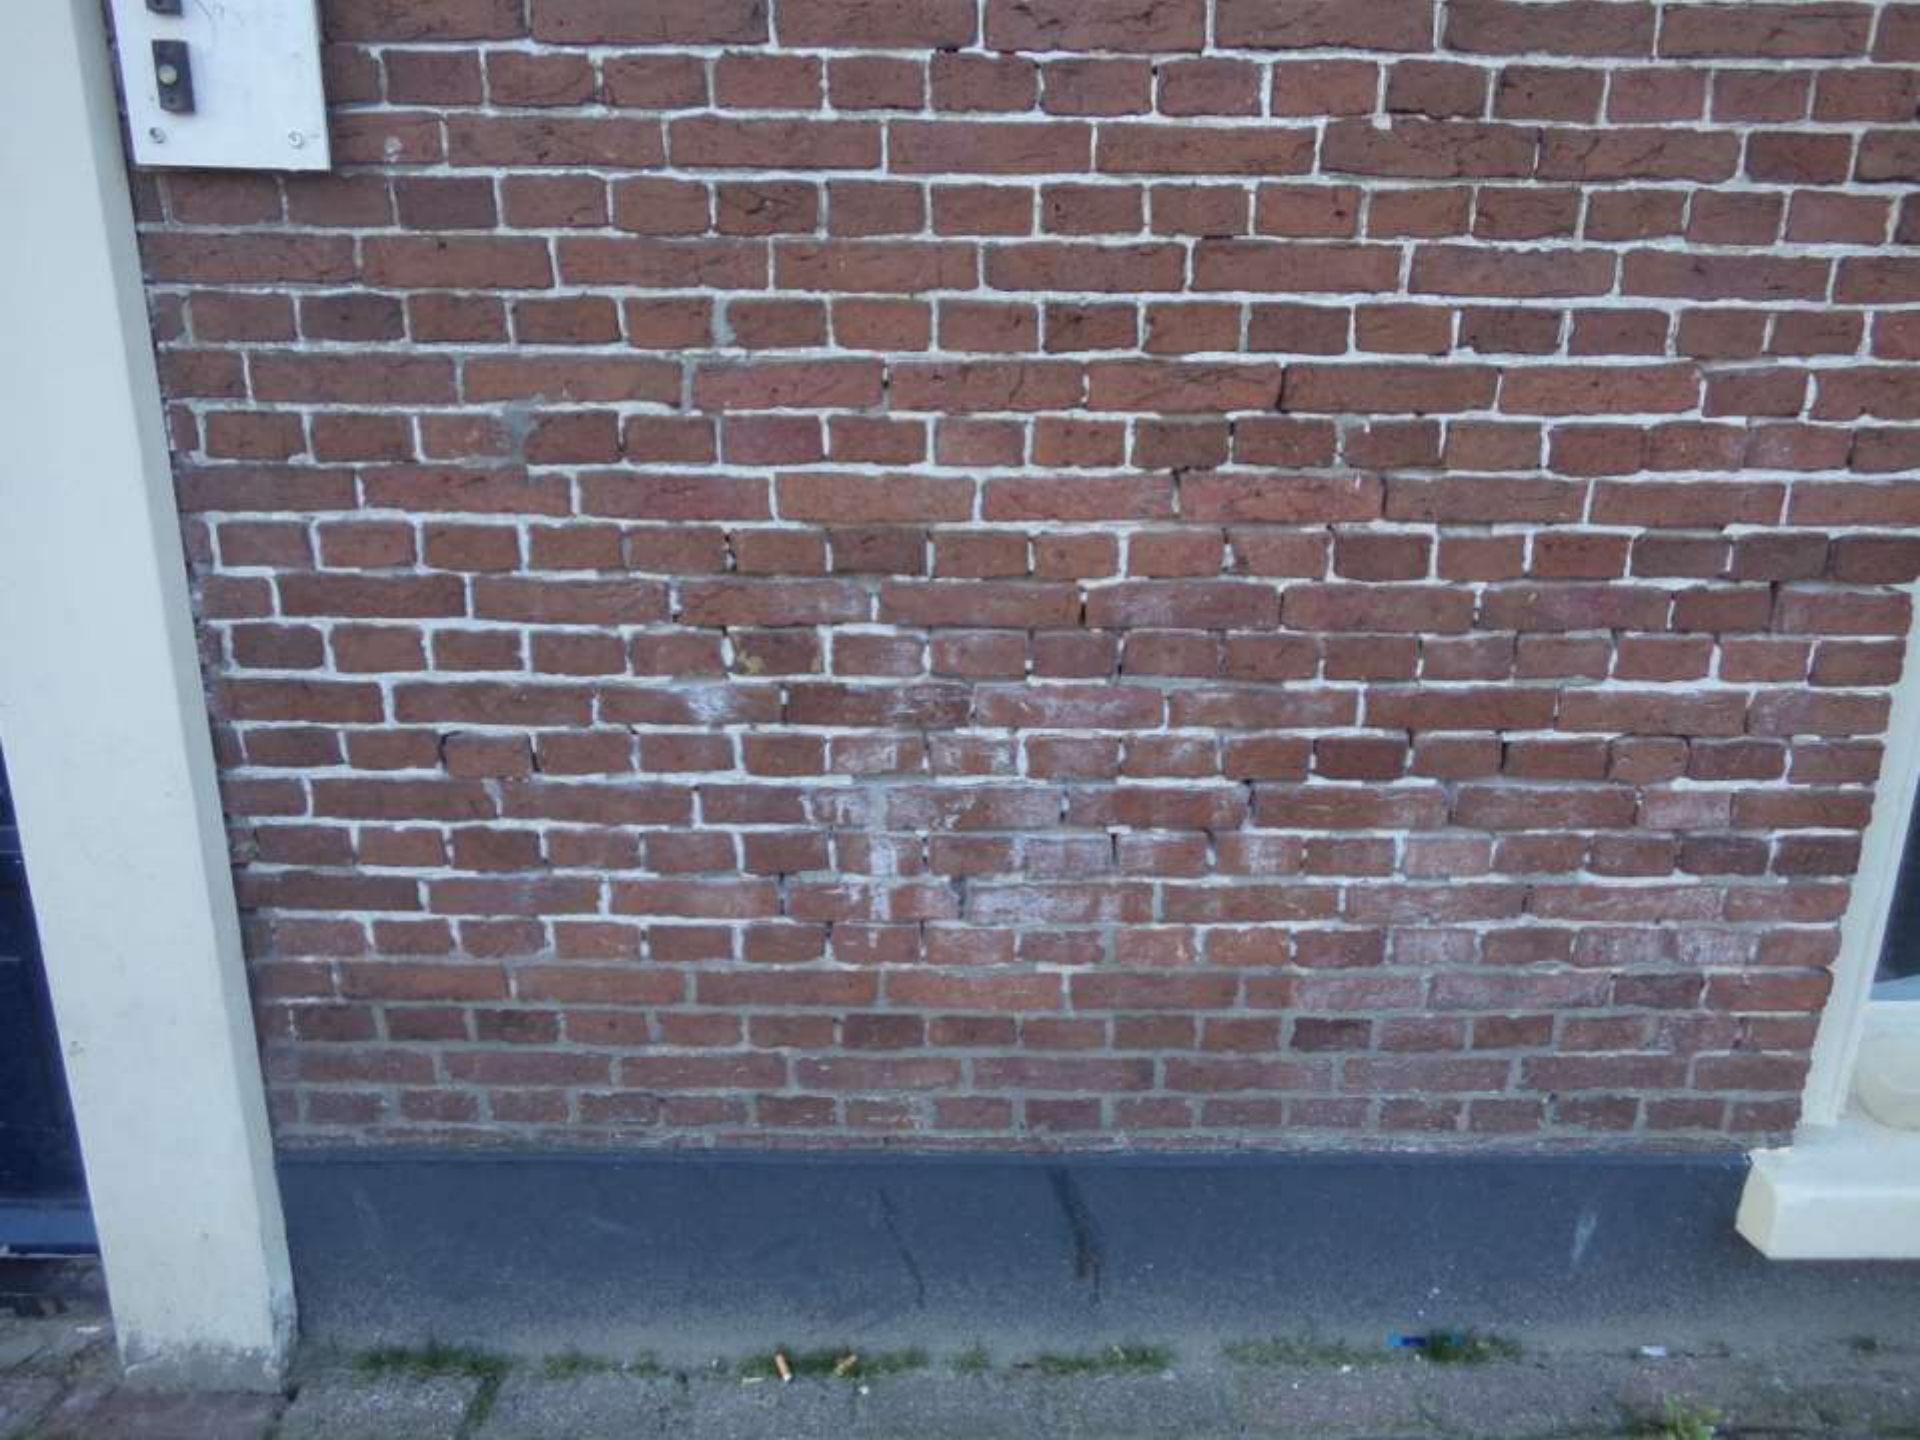
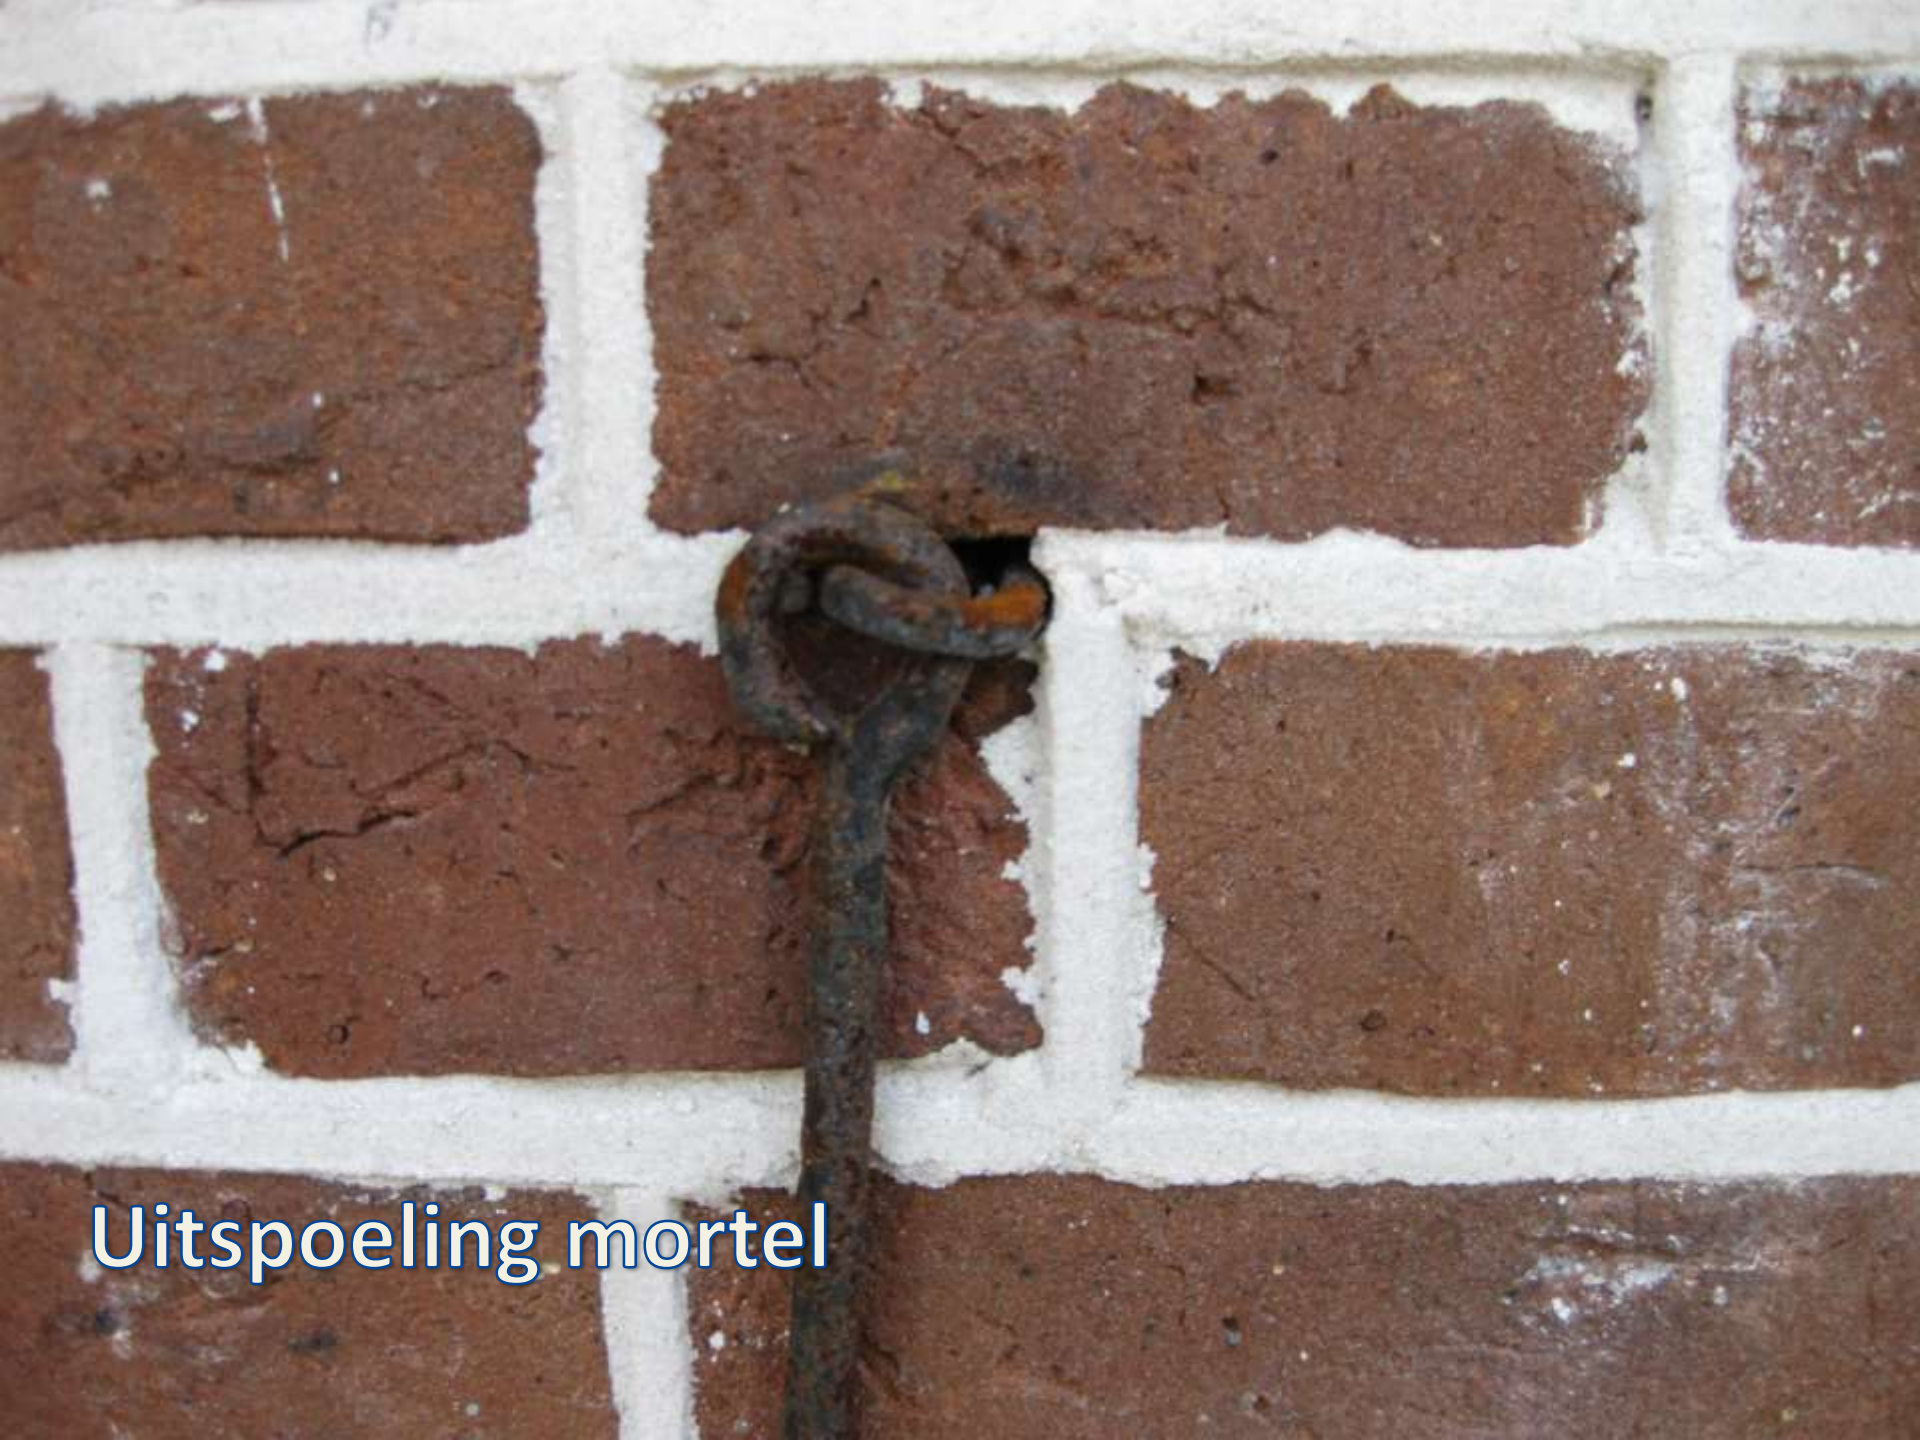
Goed voegwerk moet toch langer meegaan dan 20 jaar?

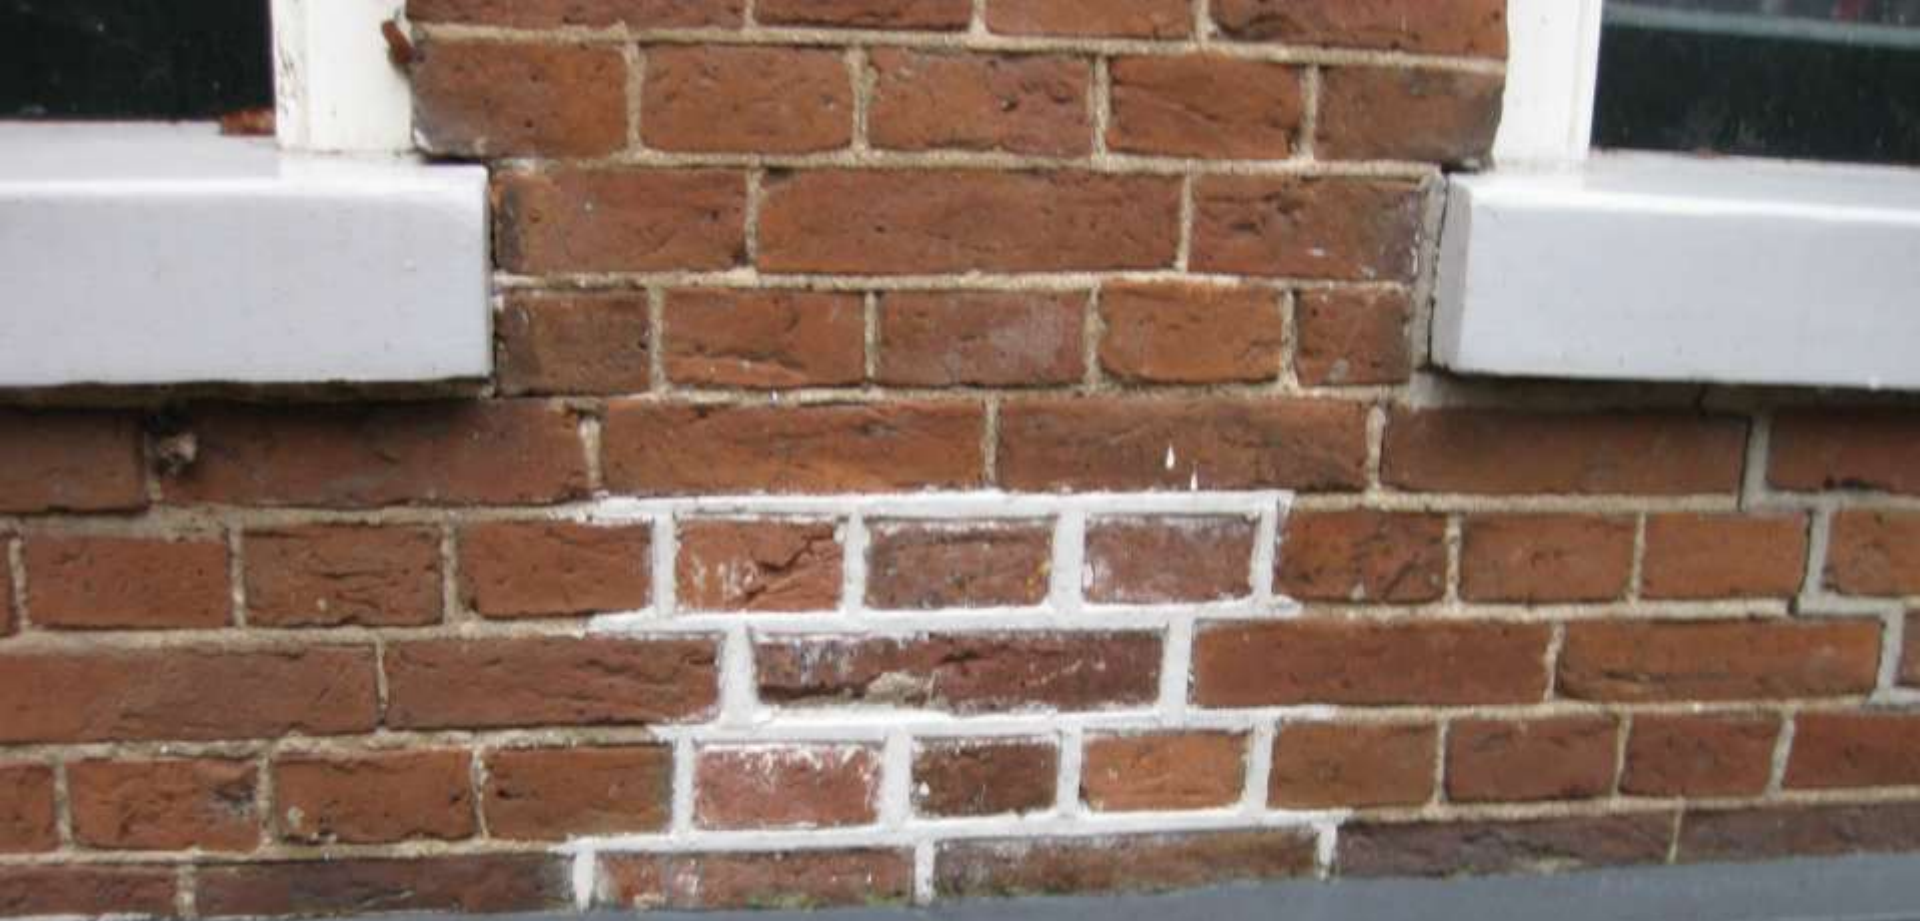
Uitspoeling mortel
