Fout voegwerk

uit de praktijk...

Gertjan Timmer
monumentenadviseur

5 maart 2015

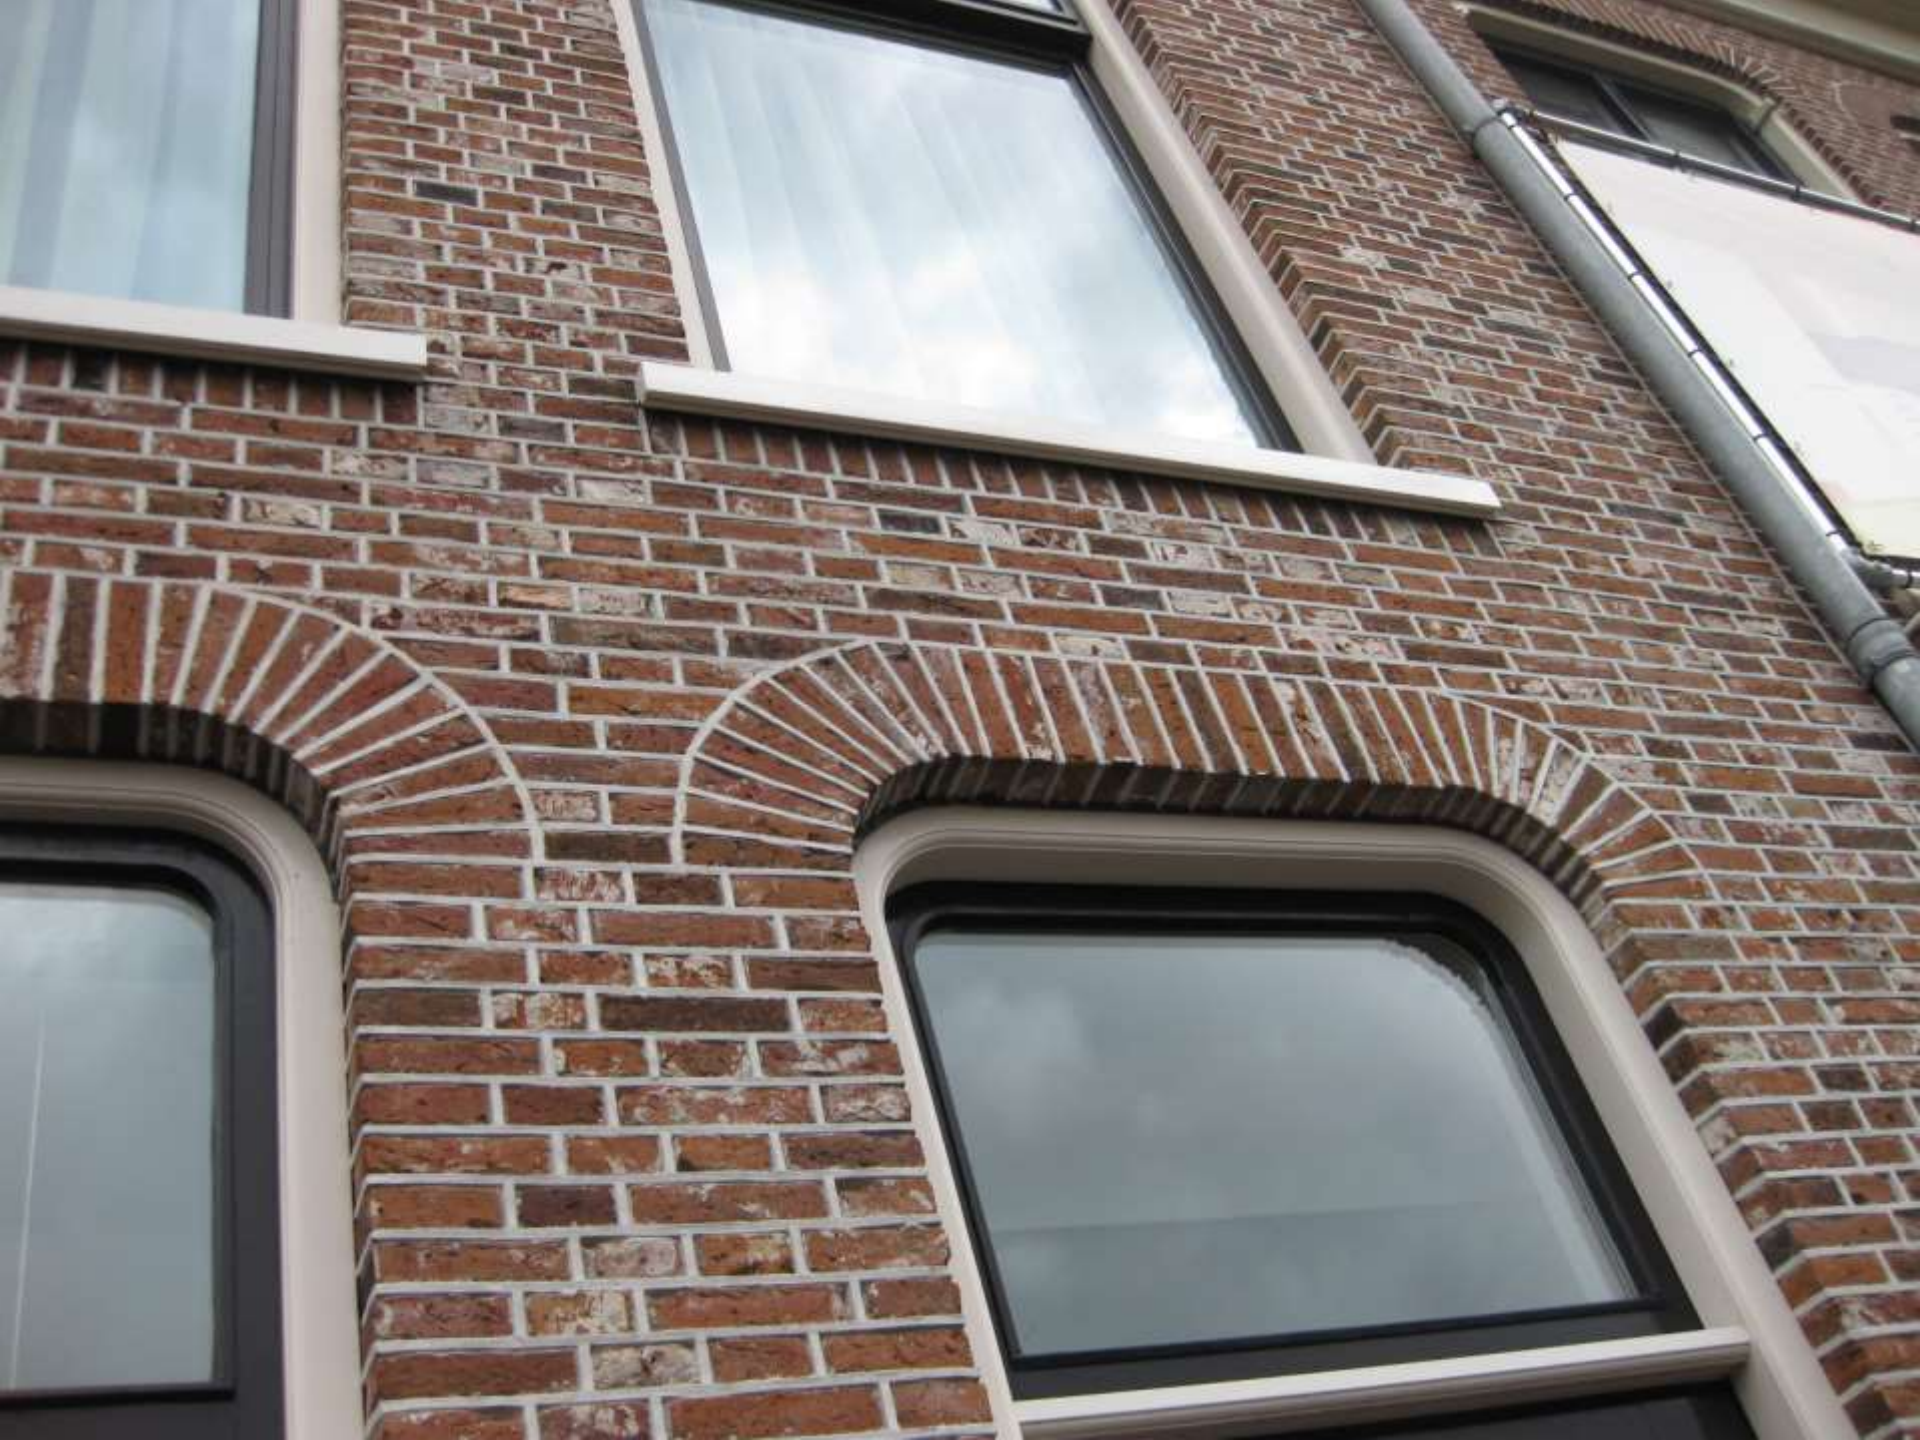
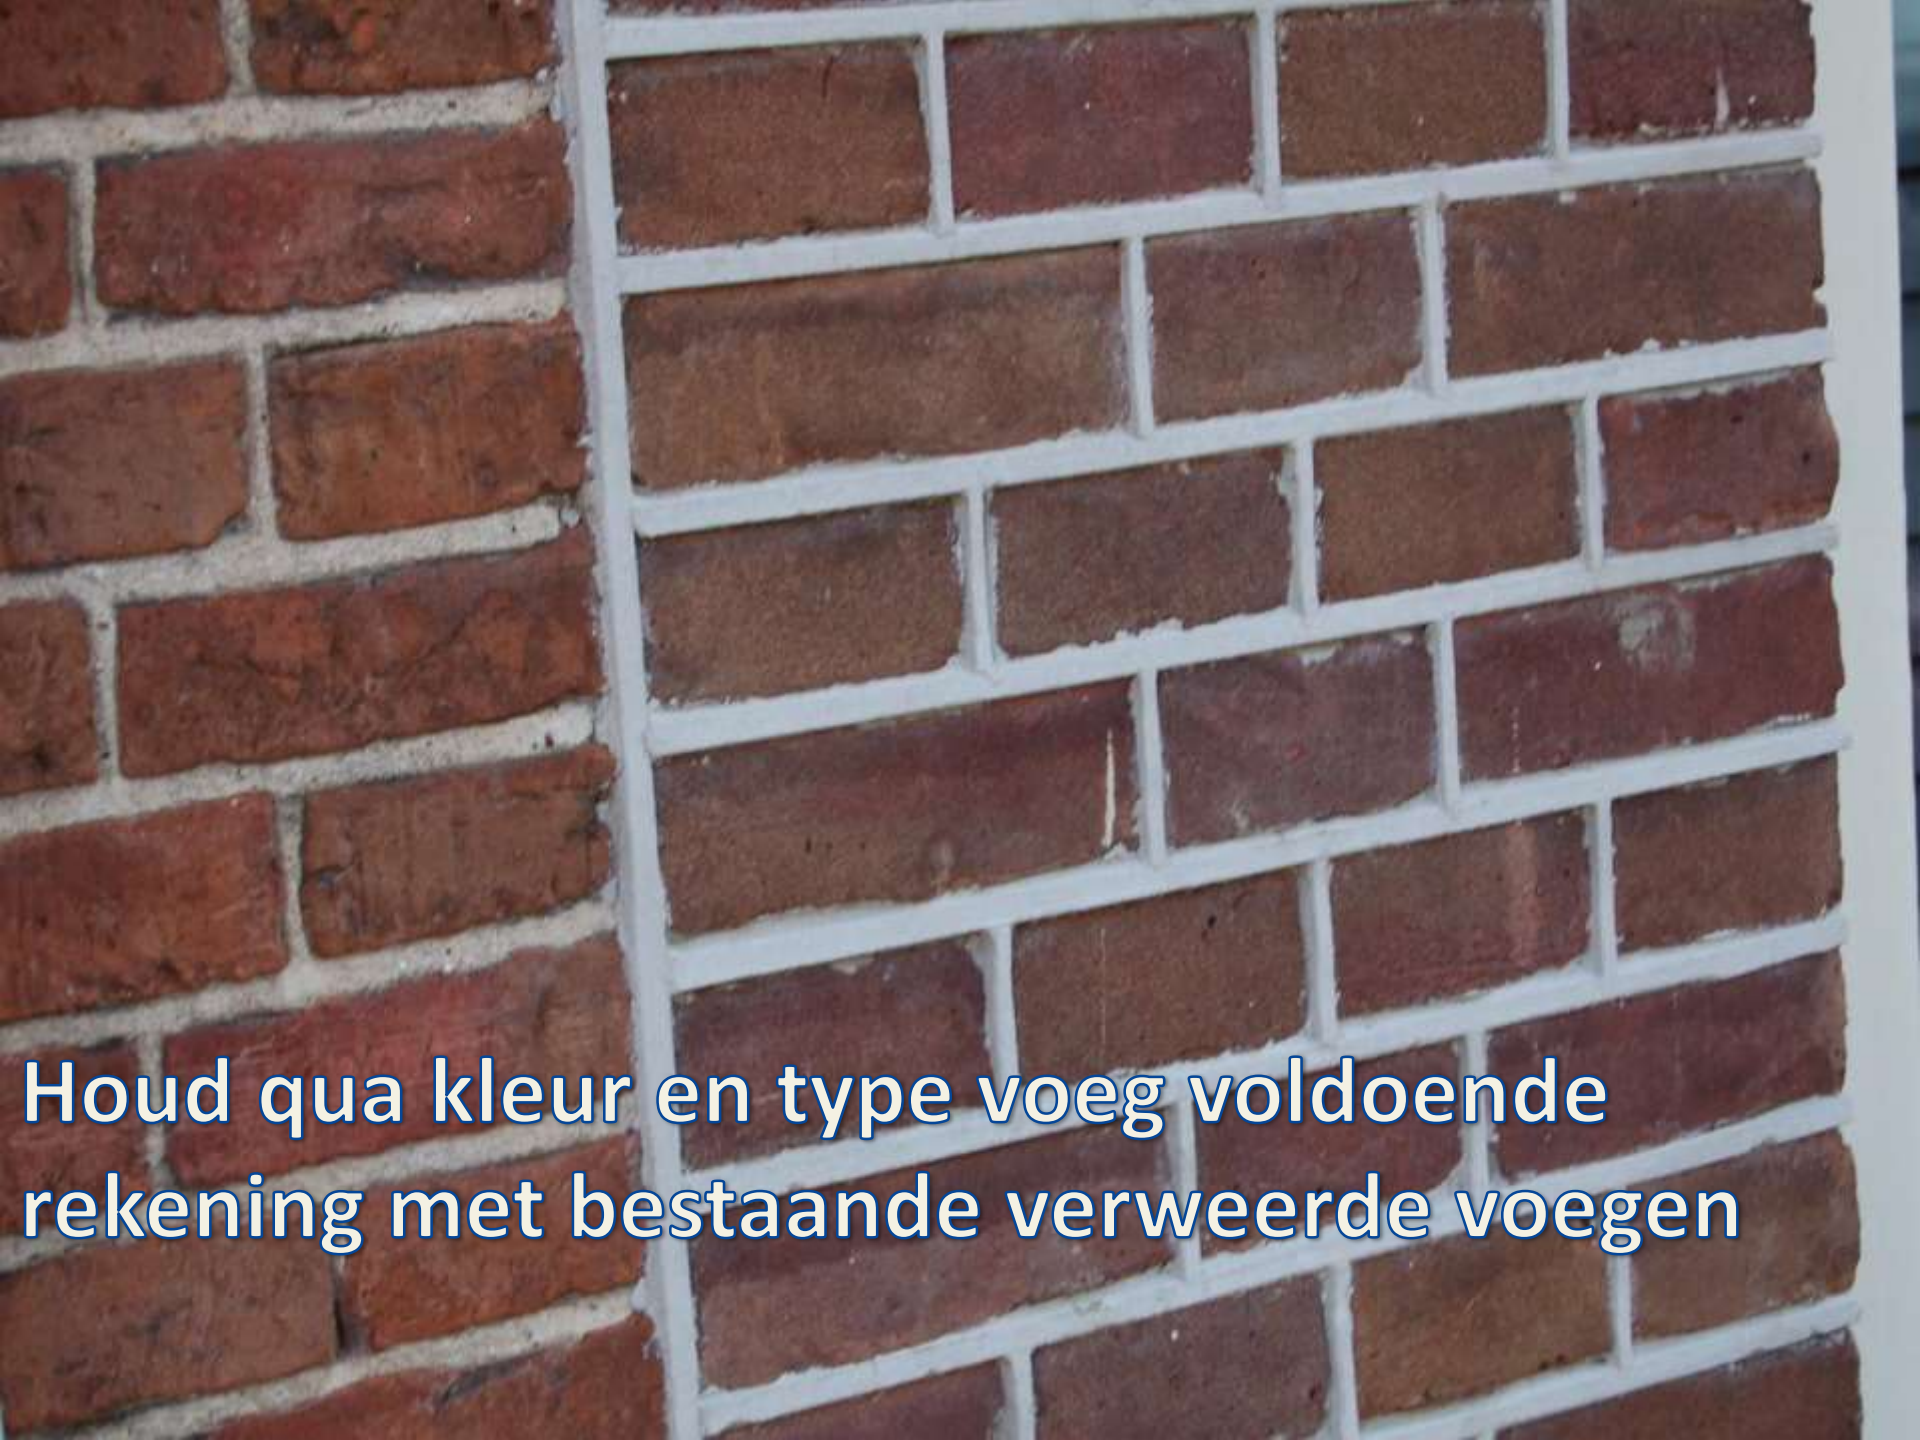
Knipvoeg in een ontpleisterde gevel?

Houd qua kleur en type voeg voldoende rekening met bestaande verweerde voegen

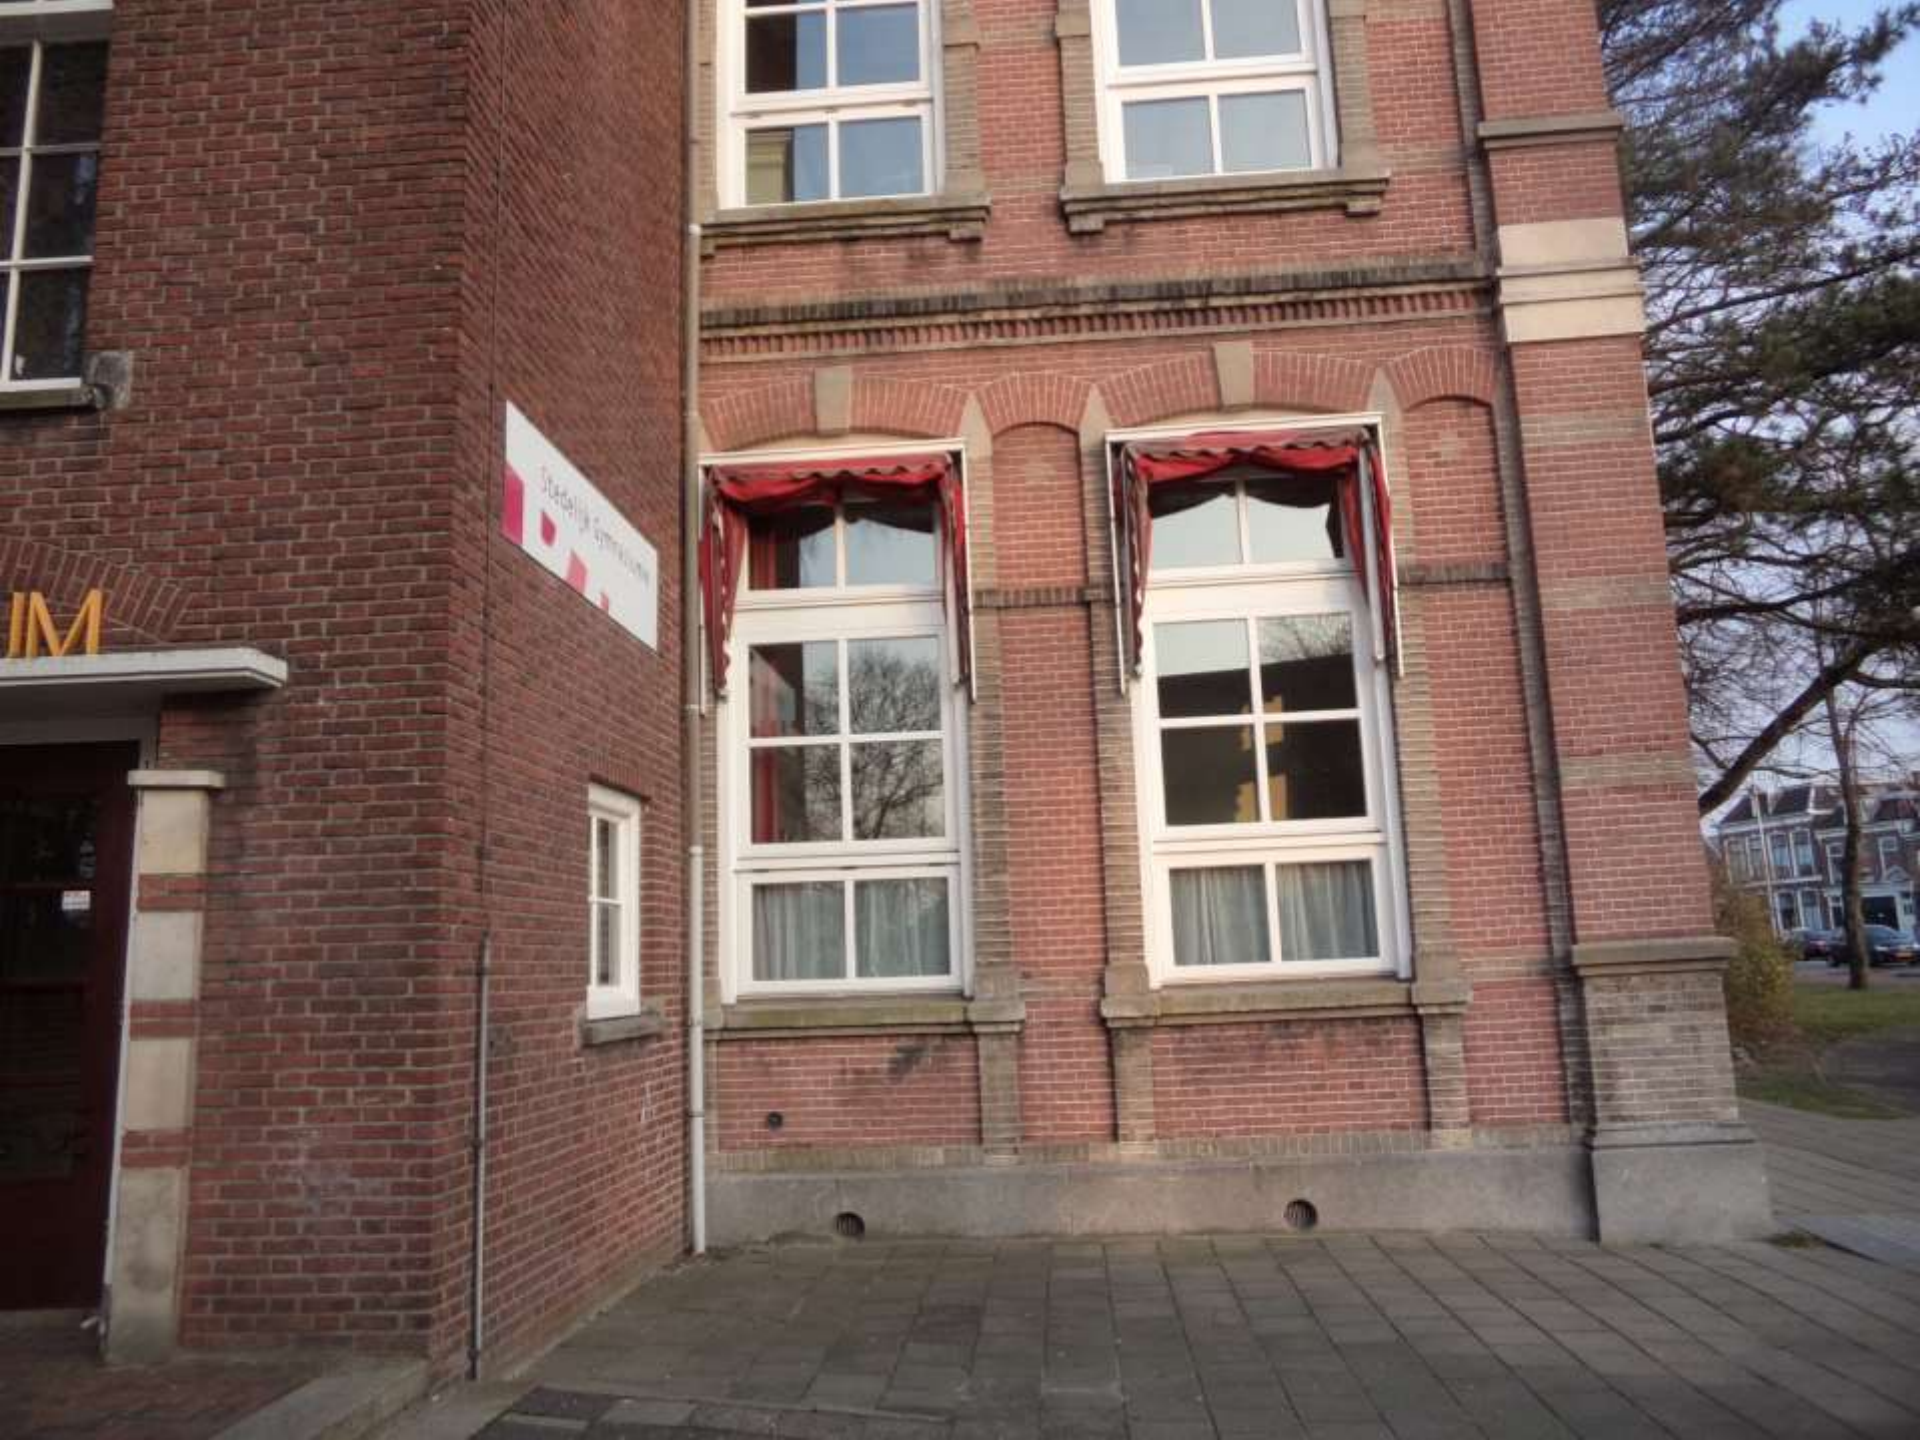
Schaduwvoeg gerepareerd met
een platvolle voeg...

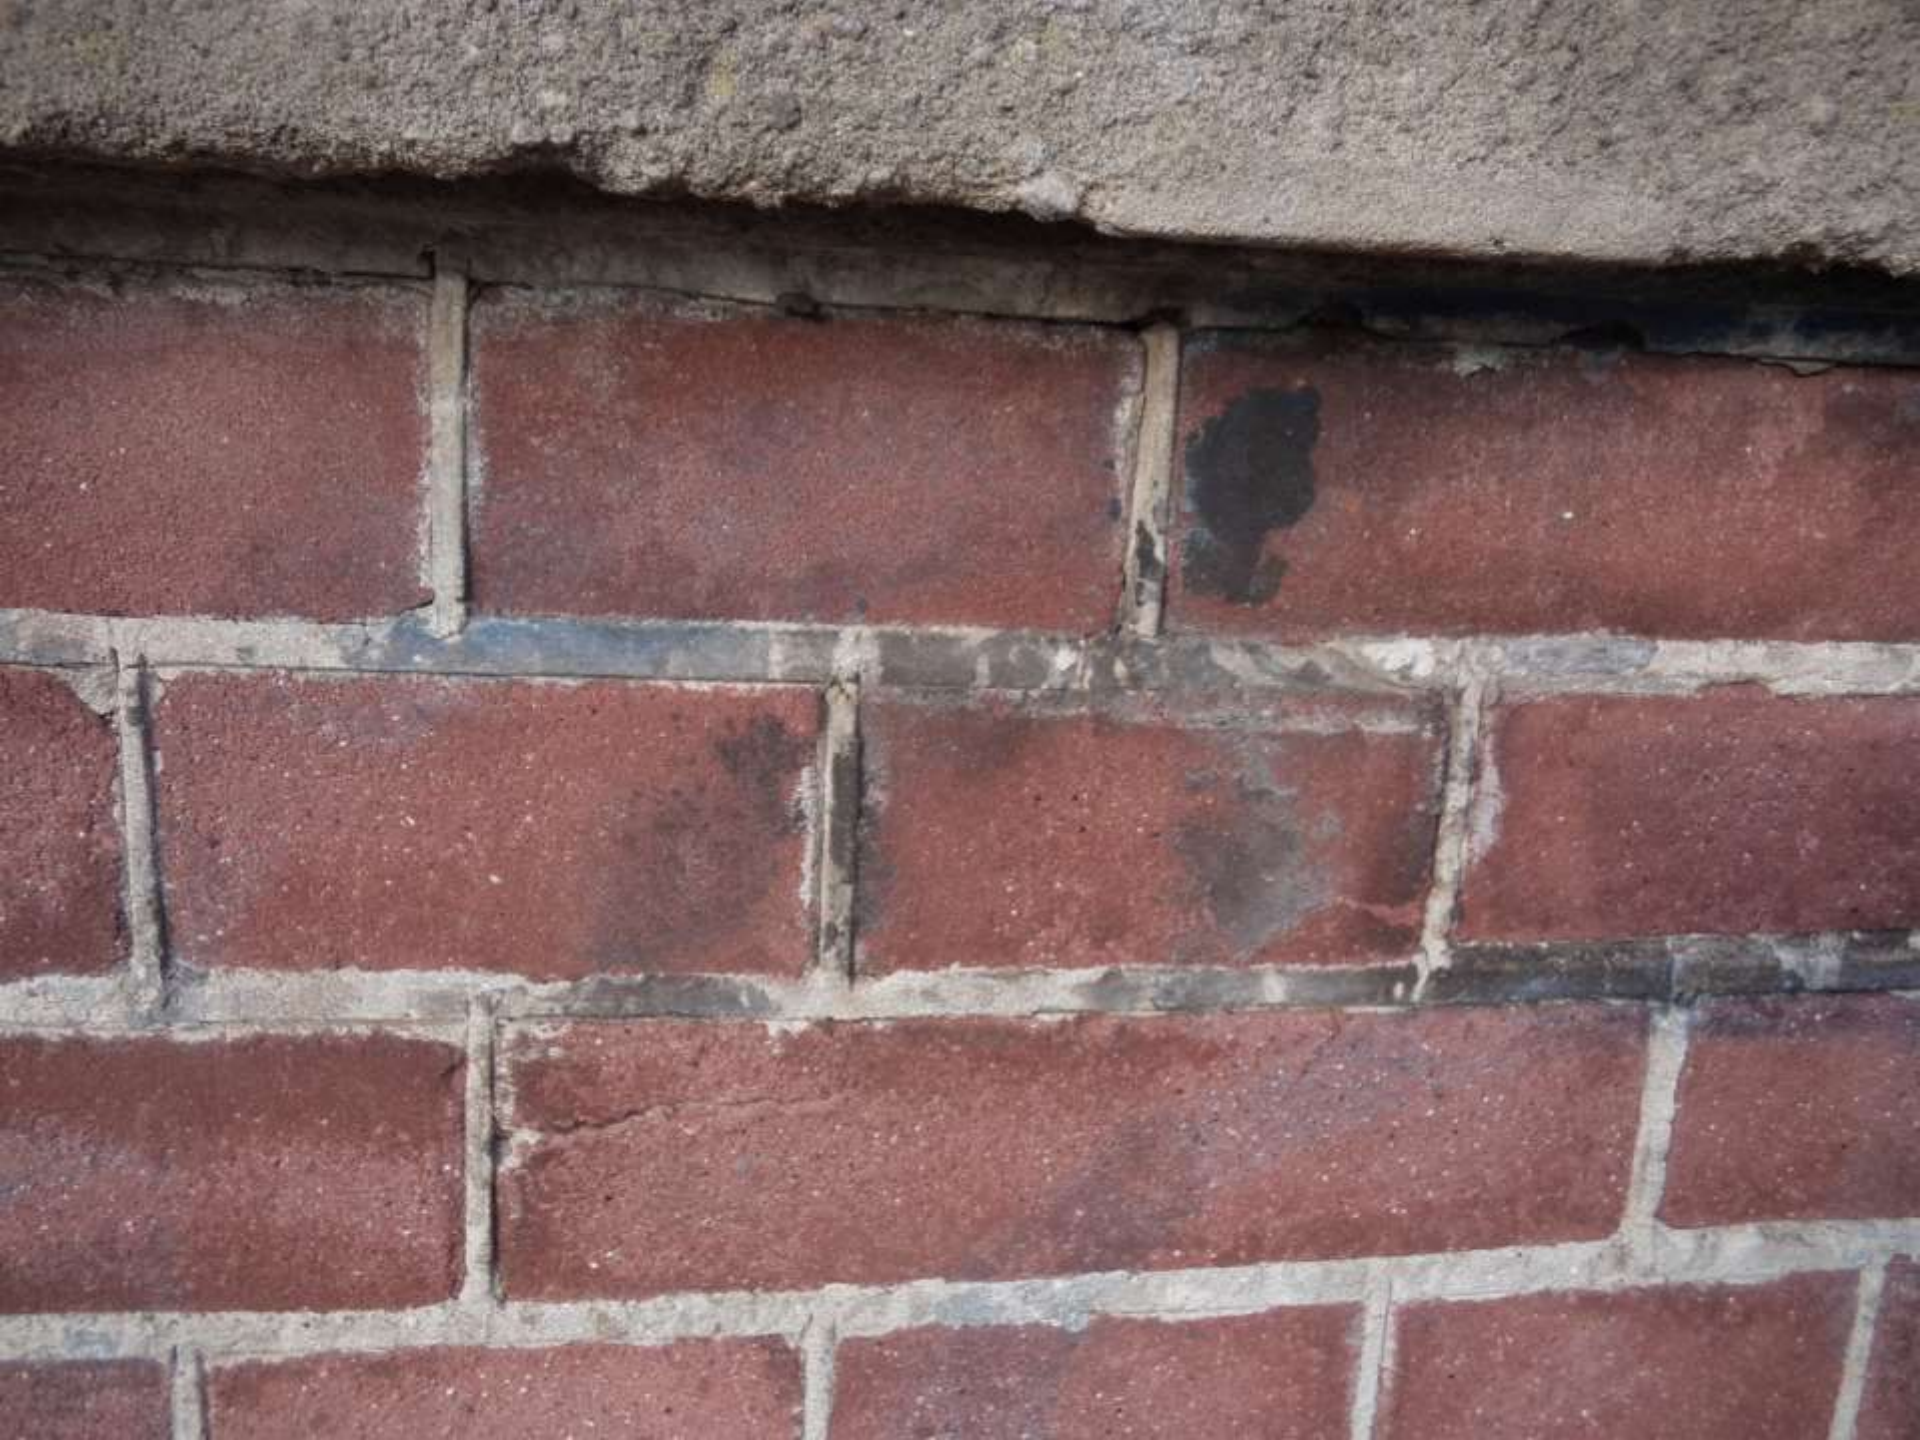
Vorstschade door ingesloten zouten

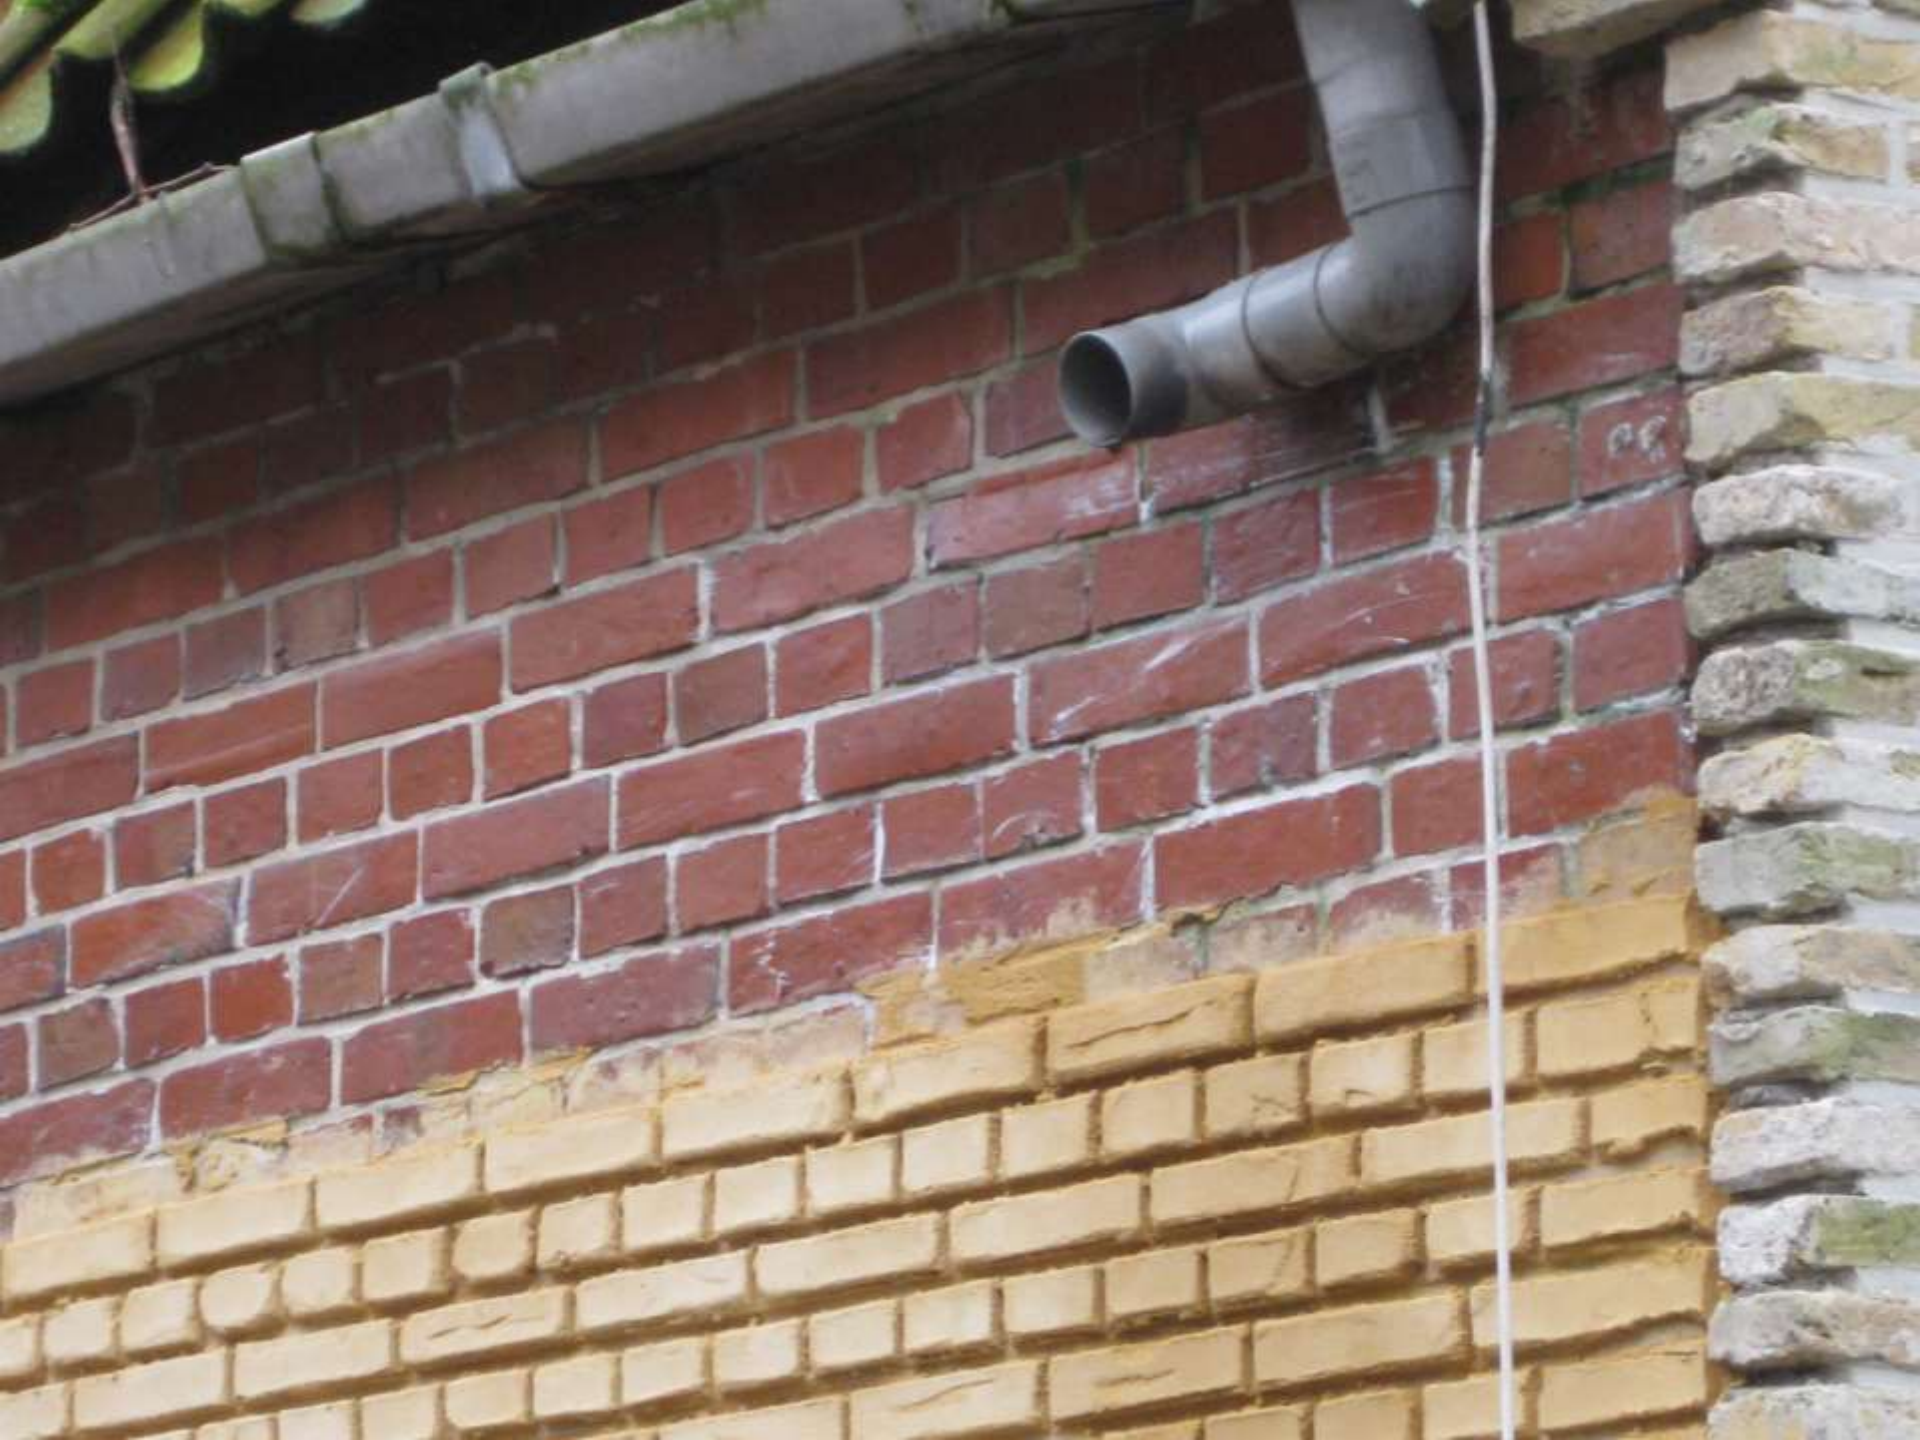
Prima voegwerk. Alleen jammer van de brute afvoeren in de gevel
